**MILL CANYON DINOSAUR TRACKSITE
PALEONTOLOGICAL ASSESSMENT
March 8, 2022**

Brent H. Breithaupt
BLM Regional Paleontologist
Wyoming State Office
5353 Yellowstone Road
Cheyenne, WY 82009

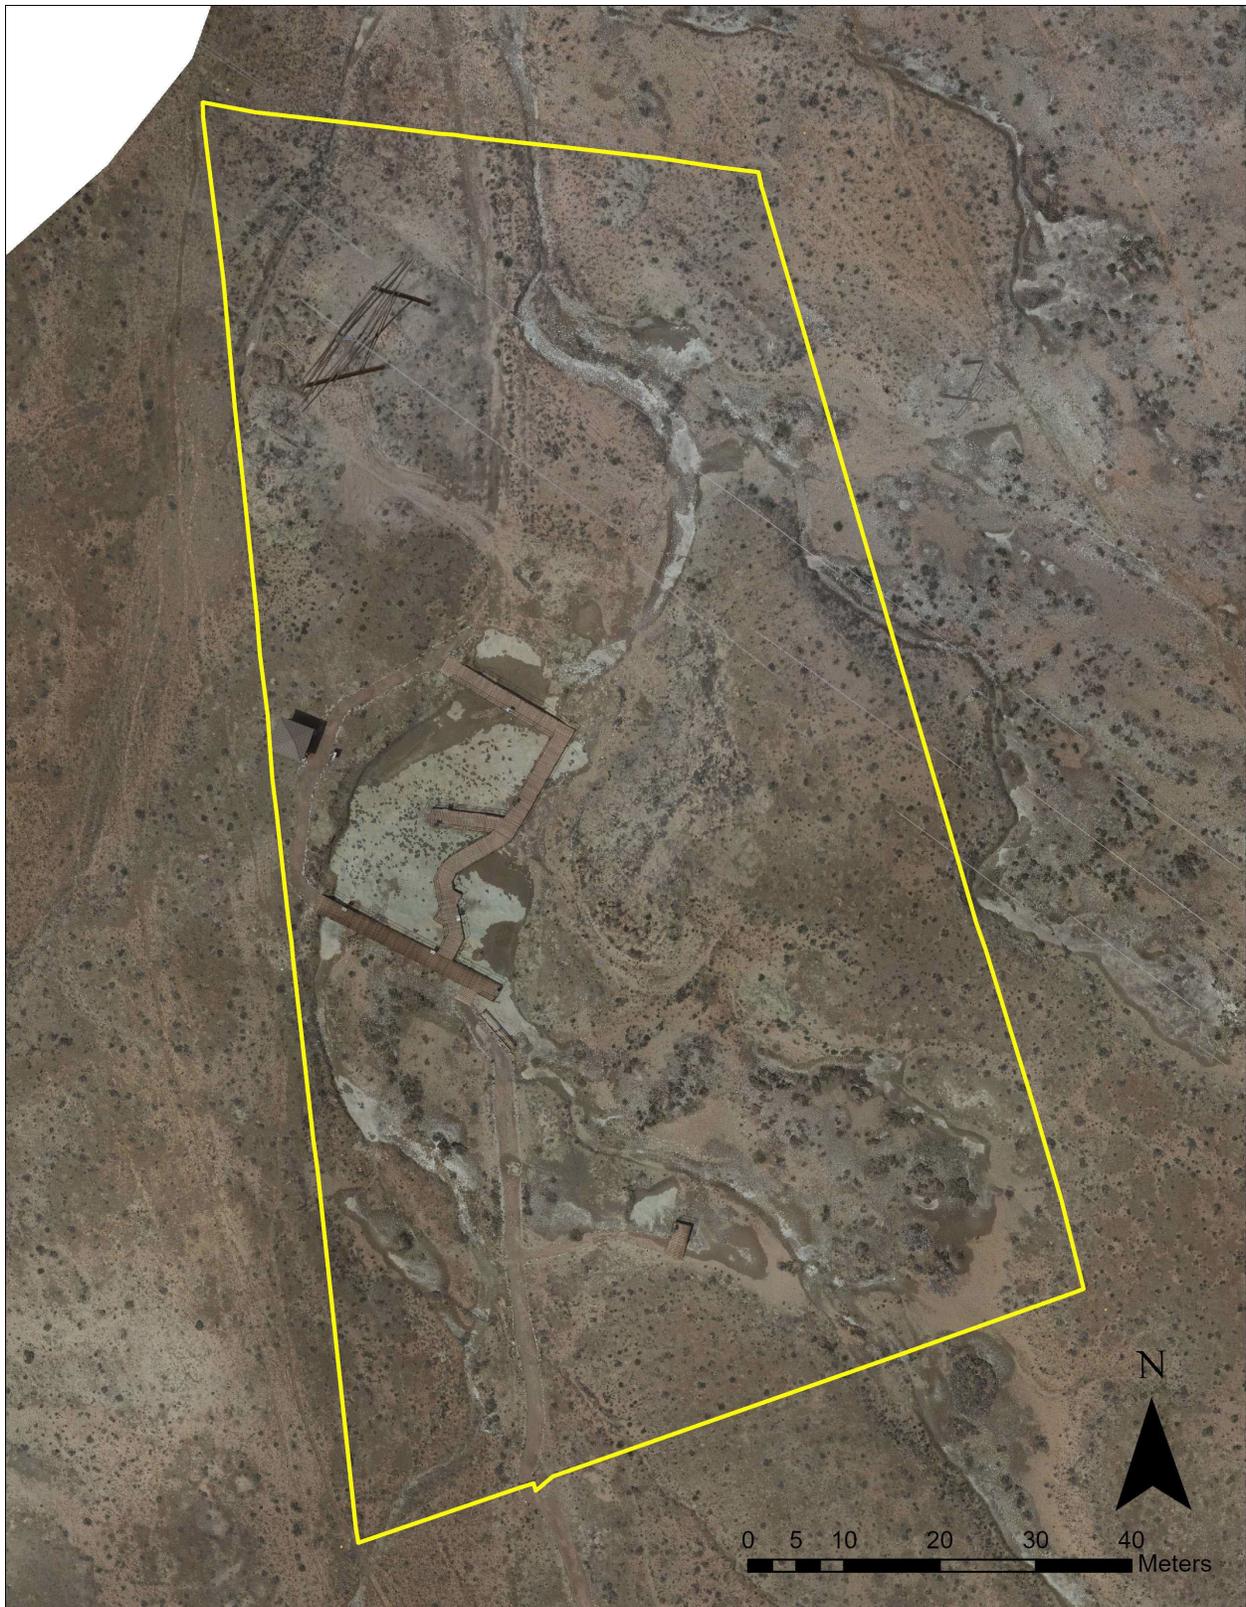
Figure 1: 2017 UAS Orthophoto of MCDT Tracksite (yellow polygon).

For this report it is important to define specific terminology. First will be defining the areas of interest. The Mill Canyon Dinosaur Tracksite (MCDT) consists of approximately 2.3 acres, currently enclosed by a fence (see Figure 1). Within the MCDT there are various areas of concern. The Interpreted Area (IA) is approximately 0.15 acres in size. Herein, the term Interpretive Area (see Figure 2) is used to describe the area previously encompassed by the boardwalk and trail (i.e., walkways). This area has sometimes been referred to as the “Main Area.” In addition, areas east, south, and north peripheral to the boardwalk are referred to throughout the document. In the future, those areas proximate to the walkways should also be formally considered part of the IA, as they contain areas of the track-bearing surface with trace fossils visible for interpretive and educational purposes.

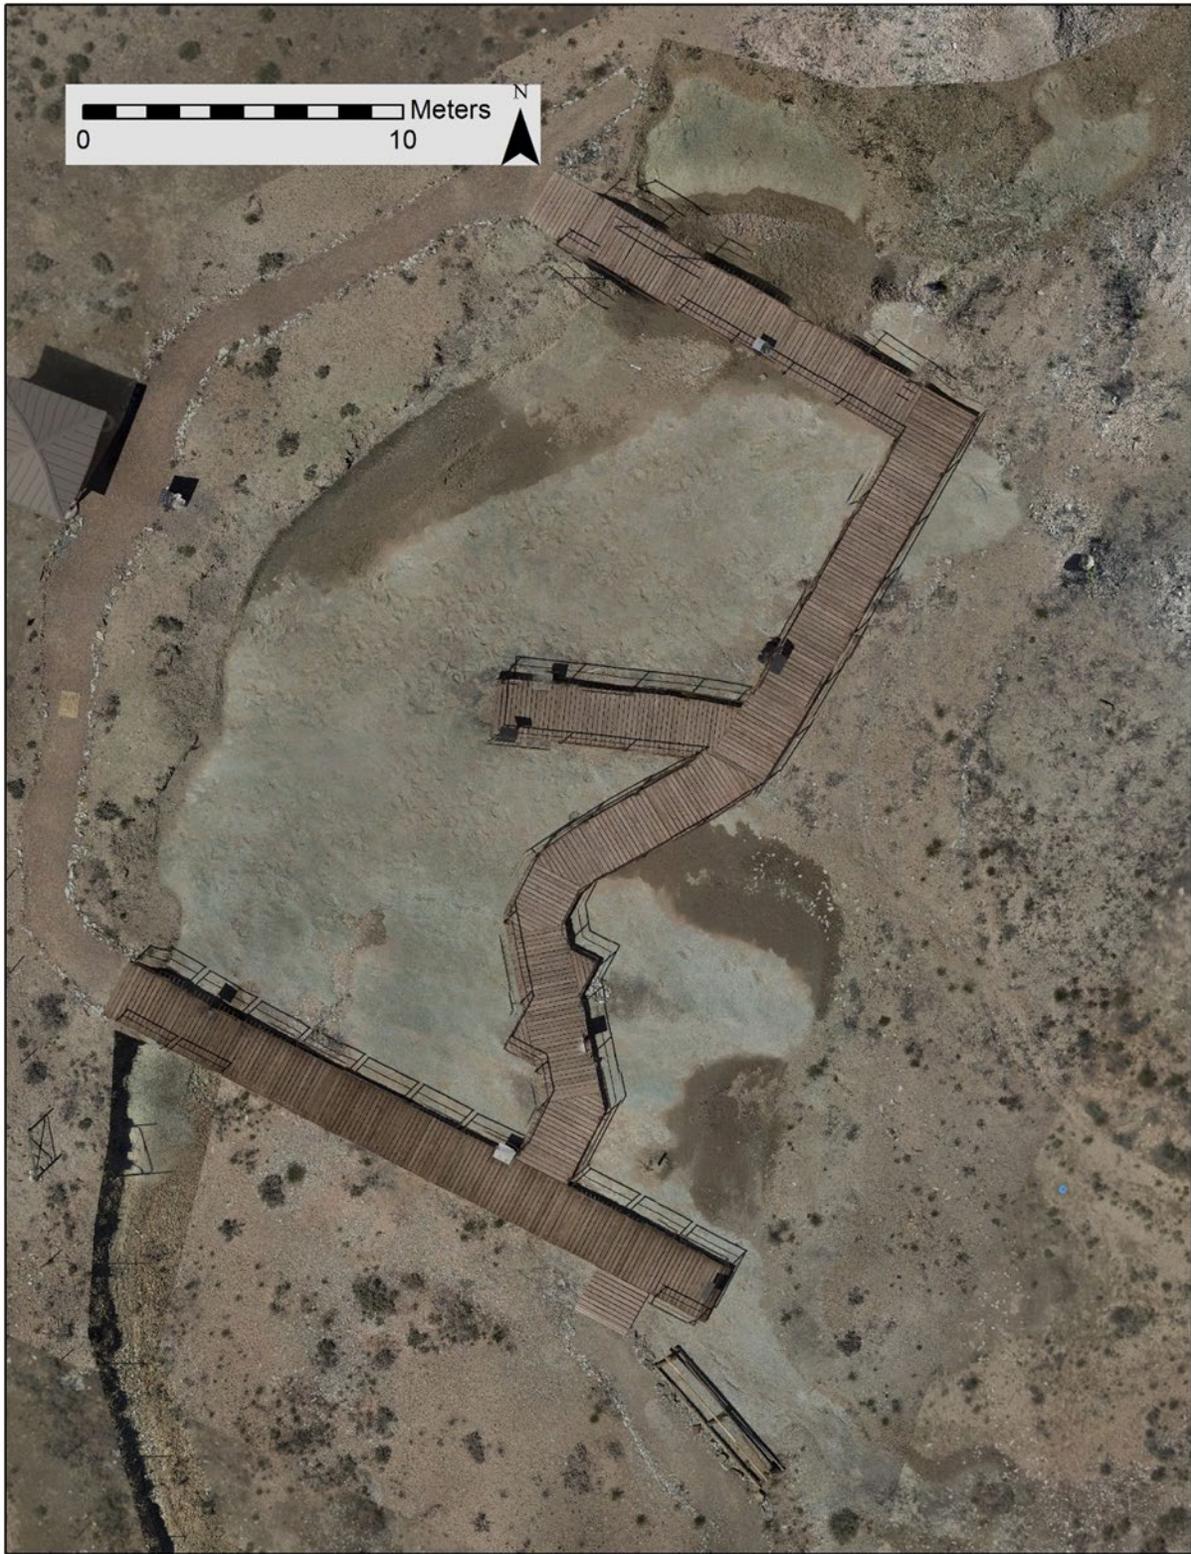
Figure 2: 2017 UAS Orthophoto of MCDT Main Interpretive Area.

1) Interpretive Area (IA) within walkways (see Figure 2)

Construction crews appear to have avoided driving on the track-bearing surface in the IA within the boardwalk and trails. This “Main Area” (referred to as the “Protected Area” in earlier reports) shows few signs of impacts due to removal of the boardwalk. However, there are some tracks that are fragmented in this area, although this damage cannot be associated with the construction crews. This

degradation was noted on only a few isolated tracks and appears to be the result of natural weathering, although these trace fossils may also have been stepped on at some point in time. The damaging effects of foot traffic on the delicate impact rims and other footprint features at the site illustrates the need to keep the public off the track-bearing surface as much as possible. Replacement of the walkways and signage are important to alleviate this concern. In addition, when the walkways are replaced in the IA, great care should be exercised by the construction crews to not step on the tracks. In addition, the use of stall (cattle) mats is encouraged for those areas immediately around the walkways, where inadvertent foot impact is possible.

2) Interpretive Areas Peripheral and East of Boardwalk (see Figure 2)

Construction crews impacted track-bearing surfaces directly east of the walkways with vehicles during the removal and loading of boardwalk palettes onto the trailer. As a result, trace fossils were damaged. In this area, the track-bearing unit is either exposed or located very close to the surface. Proximate to and along the northeastern side of the boardwalk an important crocodile slide track (similar to the one formally interpreted on the trail) is partially buried by sediment. Unfortunately, this trace was repeatedly driven over, as recent tire tracks indicate that this area was impacted by the backhoe and other vehicles. This trace fossil appears to have sustained some fracturing damage. The location of this trace is within the area designated as cleared for traffic in the development plans. However, this spot is well-documented and should have been located and flagged for avoidance.

In addition, areas along the southeastern side of the boardwalk are also known to contain significant footprints. This area was not cleared for vehicle travel and tracks are known to occur there. However, this area was also impacted by vehicle traffic associated with the removal and loading of the boardwalk. Although a few damaged tracks were noted in this area, it is unclear when and why degradation occurred. This damage most likely happened from natural weathering and foot traffic at some undetermined point in time. This location should have been flagged for avoidance and construction crews should have avoided driving vehicles in the area. In addition, construction crews need to be informed that the previous boardwalk was laid nearby and in some cases over areas that contain tracks.

3) Areas Peripheral and South of Boardwalk (see Figure 2)

Areas immediately to the southwest and southeast of the boardwalk contain

exposures of the track-bearing unit. Although it does not appear that these areas were affected by the boardwalk removal, crews should be cautious in these areas when replacing the boardwalk. Again, areas containing tracks should be designated and flagged for avoidance and special care should be taken when working in those areas (e.g., crew briefings and use of stall mats).

4) Area Northwest of Boardwalk in Northern Area (see Figures 2 and 3)

An area of outcrop proximate to the northwest corner of the boardwalk in the Northern Area (NA) contains a variety of footprints (e.g., theropod, ornithopod, and sauropod) many of which can be seen from the interpretive boardwalk and trail. Tracks in this area were previously noted and the area was not cleared for impacts. This area should have been flagged and avoided. The track-bearing unit in this area is partially covered by sediment, although impact rims of the tracks are clearly visible. Recent tire tracks indicate that this area was impacted by the backhoe and perhaps other vehicles. Heavy foot traffic was also noted. Close examination of the trace fossils in this area shows signs of recent breakage and fracturing of the brittle impact rims around a few of the tracks.

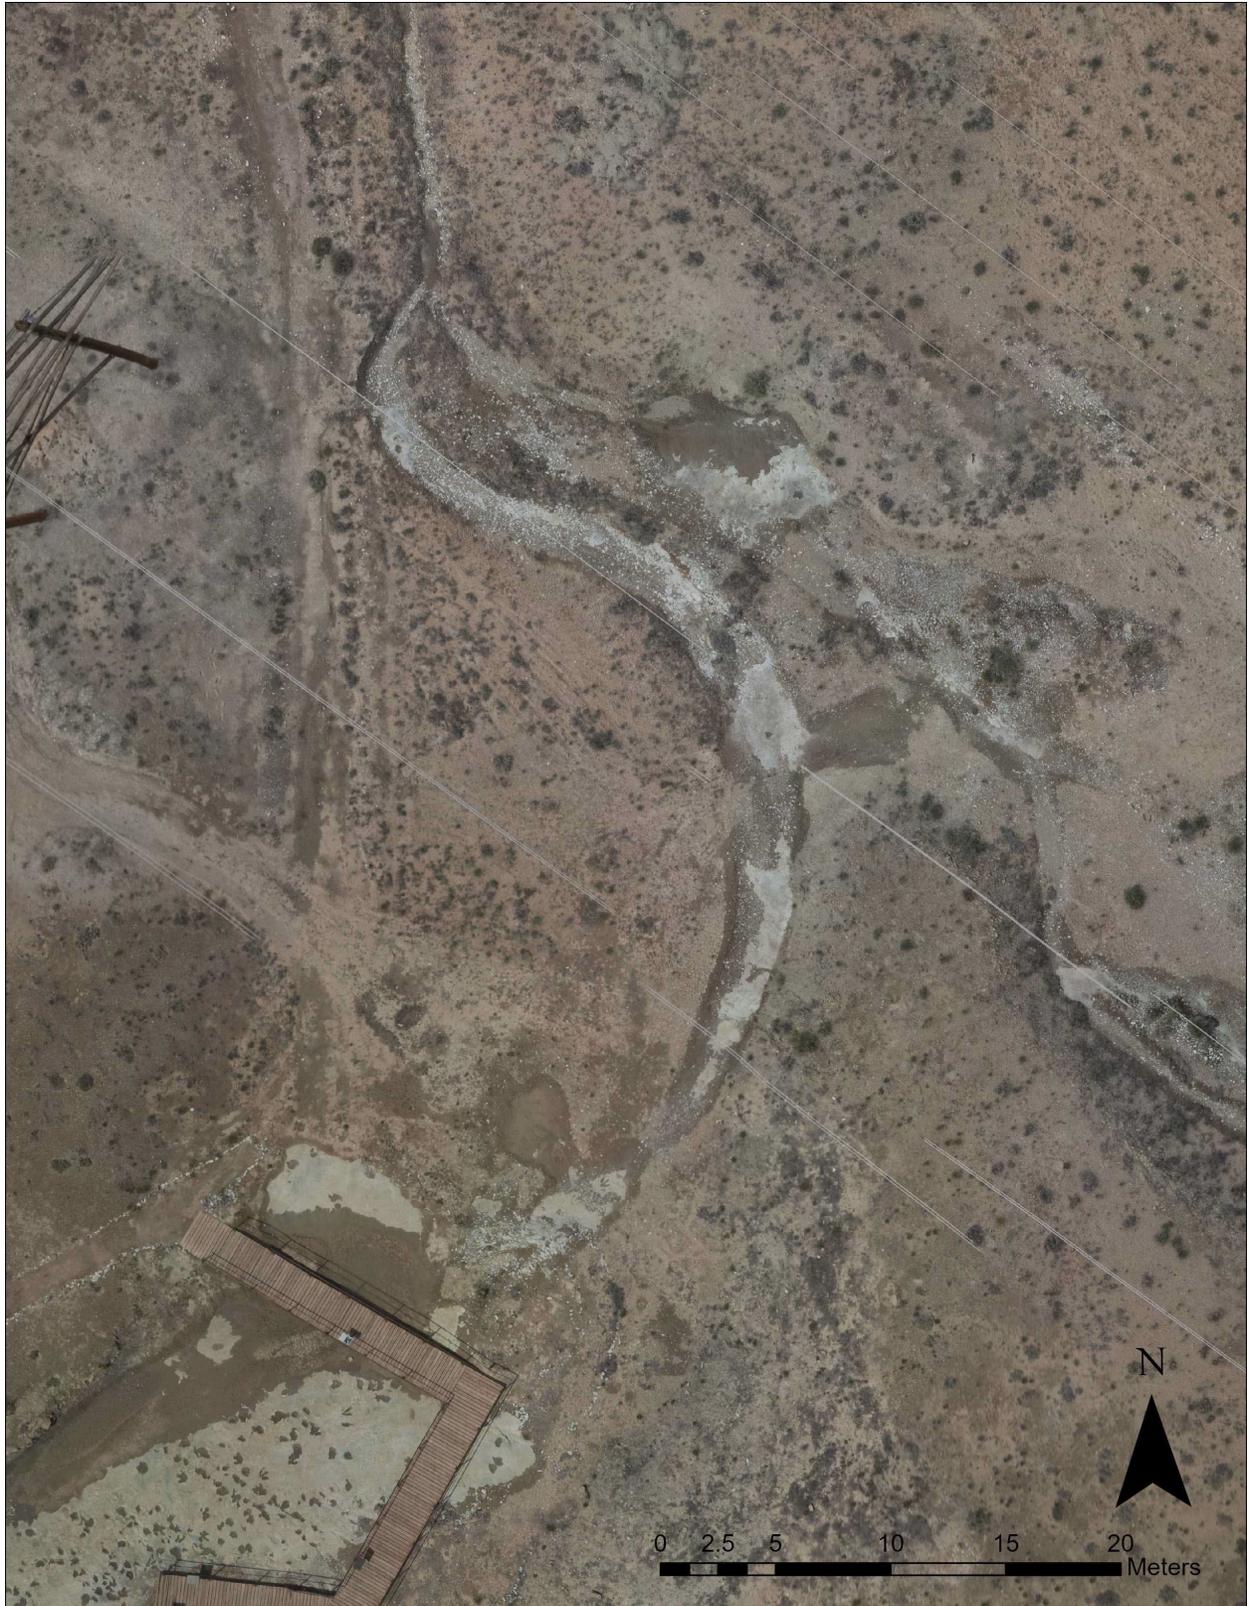
Figure 3: 2017 UAS Orthophoto of MCDT Northern Area.

To the north of the IA is an area (see Figure 3) designated as the Northern Area (NA). At approximately 0.42 acres, this area contains several exposures of the track-bearing unit with significant tracks and traces. This is also the area of previous vehicular travel into the site. The access road to this area has been closed for many years. Within this report, the term “Protected Area” is not used for the IA, as BLM is mandated to manage and protect important paleontological resources on all BLM-administered lands (FLPMA, PRPA). The track-bearing unit is located throughout this region, but there are only certain areas where this unit is exposed or located close to the surface. In many places the track-bearing unit is only covered by a few centimeters of sediment. In these locations potential impacts and possible damage to fossilized tracks and traces is highest.

5) Other Areas North of Boardwalk in Northern Area (see Figure 3)

During construction activities, various areas north of the boardwalk in the Northern Area (NA) were heavily impacted by vehicular traffic and a staging area for palette loading. This area was cleared for disturbance, as it had been previously used for vehicular access to the tracksite and some of the outcrops were covered with sediment. However, the track-bearing unit is located throughout the area and is either exposed or buried by a thin layer of sediment. In many places, tracks are clearly visible at the surface. Recent tire tracks indicate that this area was impacted by the backhoe and other vehicles. Tracks and track-bearing surfaces were repeatedly driven and walked over in this area and sections of the boardwalk were stacked on top of an already fragmented exposure of the track-bearing surface. In the NA there are several very important exposures containing previously documented tracks. These outcrops should have been marked and flagged for avoidance. Several tracks in this area experienced fragmentation from construction activities, especially a large theropod footprint, which is part of a long trackway (step #25) that extends from the IA north. Although a large ornithopod

(“hadrosaur”) track was reported as damaged and vehicle impacts occurred on this feature, high-resolution orthophotos indicate that it was already fractured when the photos were taken five years earlier. Other track features that were buried under boardwalk palettes also appear to show fracturing that was recorded years earlier. Outcrops in this area have been naturally degrading for well over a decade. Other outcrops of the track-bearing layer in this area have clearly exposed tracks. Although driven over, they don’t appear to show evidence of recent damage.
