# NATIONAL CONSERVATION LANDS

2022: Annual Manager's Report

# Steese

**National Conservation Area**

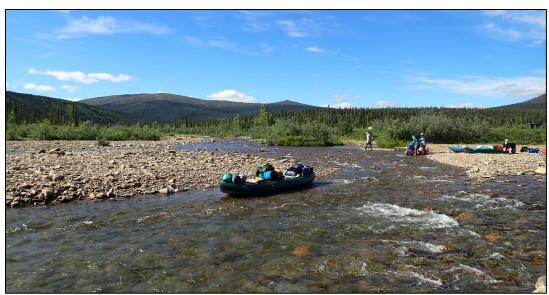
Figure 3. Photograph of Upper Birch Creek at WSR Mile-0 showing float conditions at low water level 1.5 feet, with boaters lining inflatable canoes through shallow riffle section.

At the stream gauge station Birch Creek WSR Mile -0, peak water levels varied from 2.5 to 3 feet in late May to early June, associated with snowmelt and breakup of river ice. For July through August water levels were relatively low but stable between 1.0 to 1.5 feet. Storm events in early September resulted in increased waters levels of 2 to 2.5 feet for several days. Stage of less than 1.0 foot is very low flow, meaning difficult floating, especially for large rafts (Figure 4). Stage of 2 feet is moderate flow --good float conditions. Water level data is available online to assist the public in planning float trips.

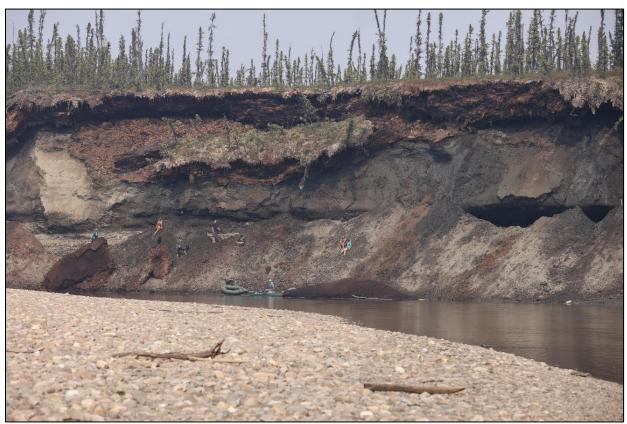
Figure 5. Photograph of lower Birch Creek showing accelerated erosion of permafrost bank in June 2022. A recreation group and boats near base of embankment, provides scale.

Increased surface erosion associated with thawing permafrost and melting ground ice results in thermokarst development in low gradient areas and increased thermal erosion on hill slopes. Detachments of seasonally thawed permafrost hill-slope areas and accelerated erosion of ice-rich river embankments are evident in the lower reaches of Birch Creek WSR, shown in figures 5 and 6.

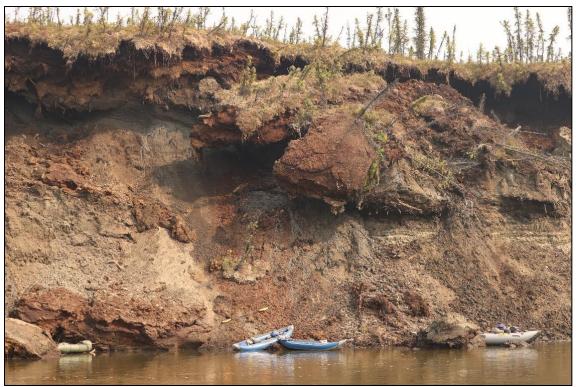
Figure 6. Streamside photograph showing unstable embankment, melting permafrost area, lower Birch Creek WSR, June 2022.

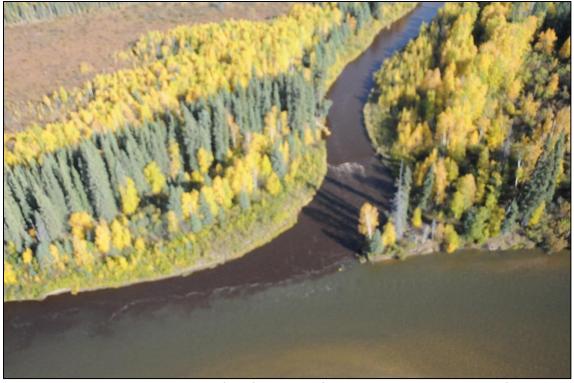
Figure 7. Highly turbid, dark brown inflow from permafrost-rich tributary, top center of photograph, entering main channel of lower Birch Creek WSR. The flow is from right to left side of photograph, July 2020.

Stressors periodically contributing to Birch Creek WSR turbidity levels include debris slides, active and abandoned placer-mined areas as well as soil instability and erosion associated with melting permafrost.

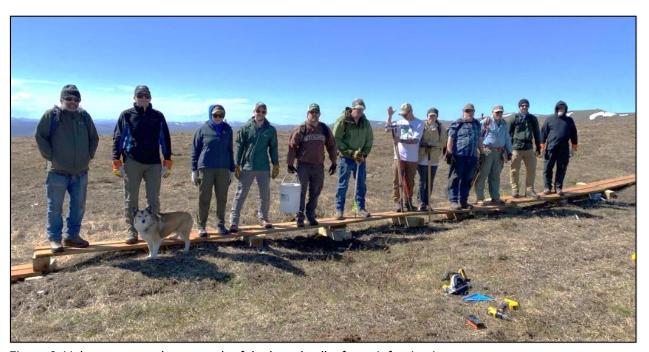
Figure 9. Volunteers test the strength of the boardwalk after reinforcing it.

During summer 2022 EIFO hosted a volunteer trail work event on the Pinnell Mountain NRT for National Trails Day. Volunteers worked with BLM to reinforce boardwalk, seed and fertilize denuded areas, pick up trash, and remove temporary signs. Local groups such as Interior Alaska Trails and Parks Foundation, Resident Hunters of Alaska, Backcountry Hunters and Anglers, and local hiking groups helped recruit and feed volunteers to make the volunteer events a success.
